**2020 GMC Technical bulletin #161b (Radio HVAC IPC blank out when operating a Snowplow ..... 2**  
**(2014 - 2019) GMC Technical bulletin #124k (Radio HVAC IPC blank out when operating a Snowplow..... 8**  
**GMC technical bulletin #131b (Elevated Engine Coolant/Operating Temperatures when Snowplow mounted).....30**  
**GMC technical bulletin #116b (Snowplow Lamp activation)..... 31**

# TECHNICAL BULLETIN

**Subject:** Intermittent Cluster, Radio and HVAC Display  
Resets on Snow Plow Trucks

**Subject:** Intermittent Cluster, Radio and HVAC Display Resets on Snow Plow Trucks

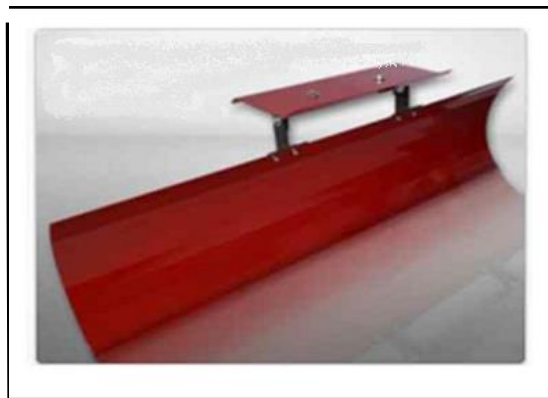
Both of the above conditions can occur due to the reduced airflow into the radiator area with the plow in the raised position. The air flow is diverted upward as a result of the raised plow and thereby does not enter the front grille area of the vehicle.

- Try lowering or repositioning (angling) of the plow.
- If repositioning attempts are unsuccessful in reducing the operation temperature, GM recommends that an air foil be added to the top of the plow, similar to the one shown below.

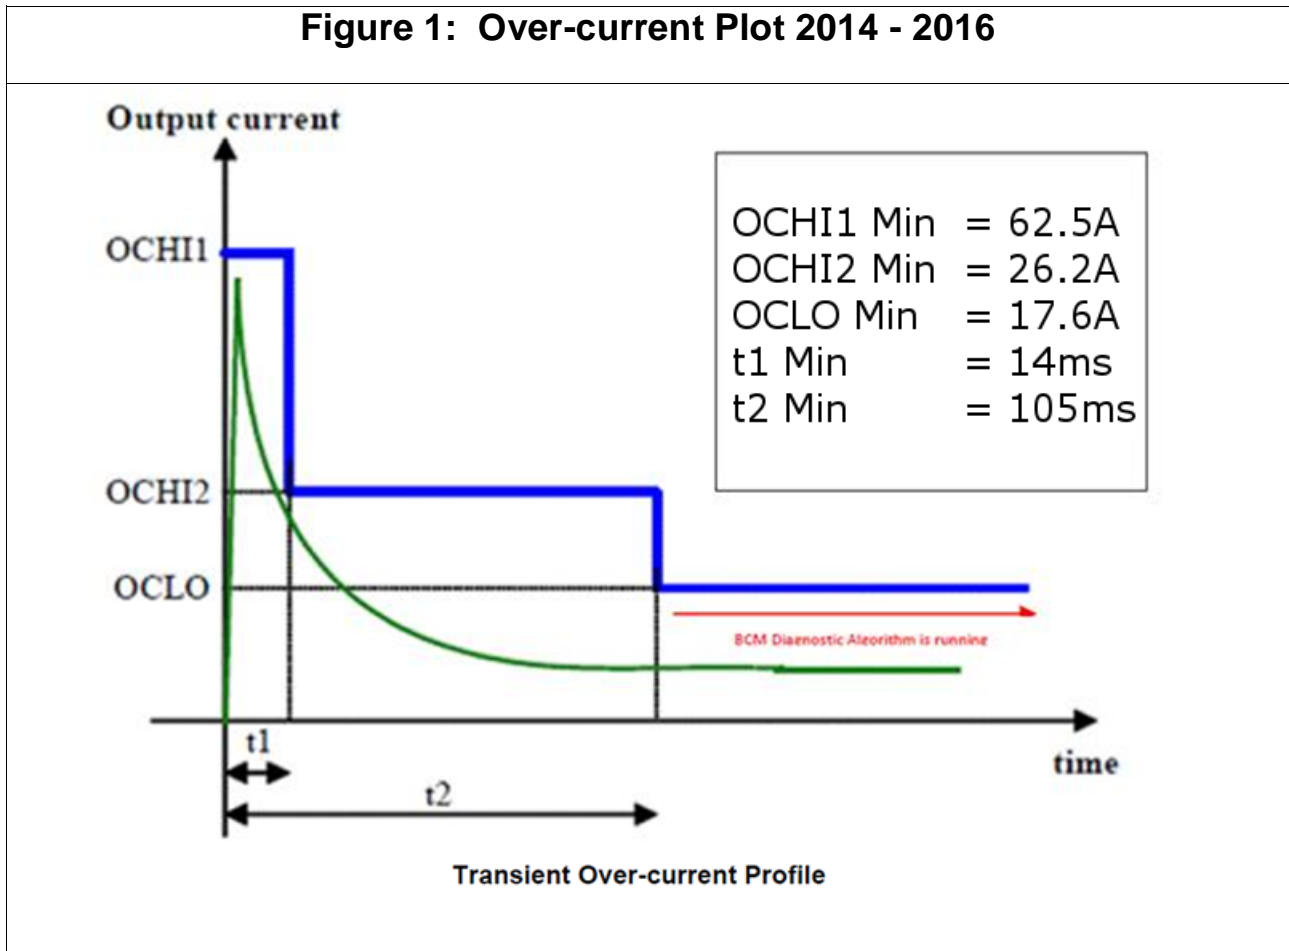
**Figure 1: Over-current Plot 2014 - 2016**

The plots below show the expected 'actual' headlamp current vs the 'over current' limits at headlamp activation. The BCM expects to see a single 'high current inrush and decay event' [current spike] as is normal with both incandescent and HID headlamps. If the headlamp circuit is switched [disconnected and then reconnected] after initial turn ON the subsequent [later] current spike may cause the diagnostic to turn the lamp off. Each time the headlamp is turned ON the diagnostic runs and a single current spike occurs. However, once normal running current is reached if a [later] second current spike occurs the BCM may turn off the lamp to protect the driver chip. Switching or interrupting the headlamp circuit causes current spikes. High current is not expected after lamp warm up and 'looks like' a short circuit.

For best results, switch lights to Park or OFF before connecting the electrical plugs when mounting the plow. This avoids current surges that could cause headlamp low beam shut down. Once the plow lights are connected the headlamps may be turned back ON.

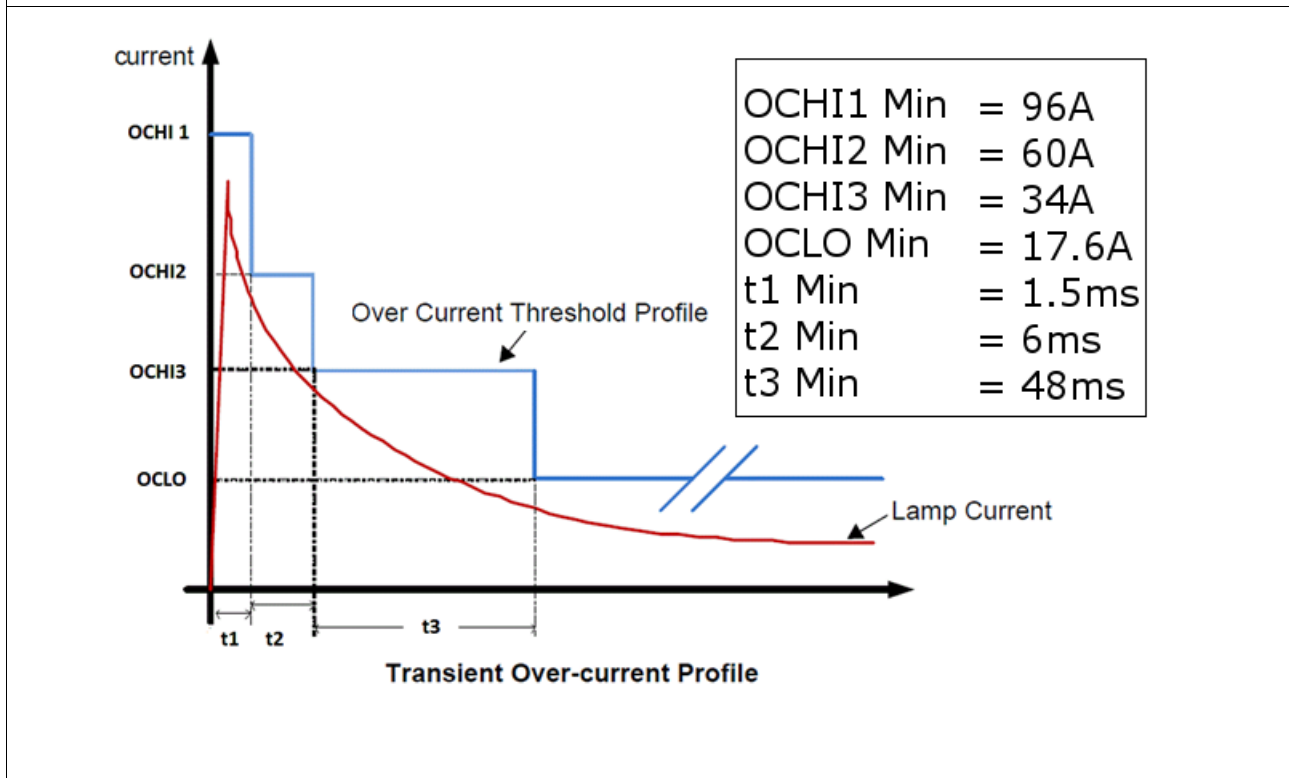
**Figure 2: Over-current Plot 2017 and later [incandescent and HID]**

Later version trucks have limited 'retry' provisions in the headlamp lamp diagnostic which renders the system somewhat tolerant to a 'switch over' event. [It will try a few times before shutting down.] Turning headlamps OFF at plow connection is best.
